**Hurricane Loss Reduction
FOR
HOUSING IN FLORIDA:**

**EFFECT OF VEGETATION ON RESIDENTIAL BUILDING
DAMAGE FROM HURRICANE ANDREW, AUGUST 1992**

PREPARED BY
THE INTERNATIONAL HURRICANE RESEARCH CENTER
FLORIDA INTERNATIONAL UNIVERSITY

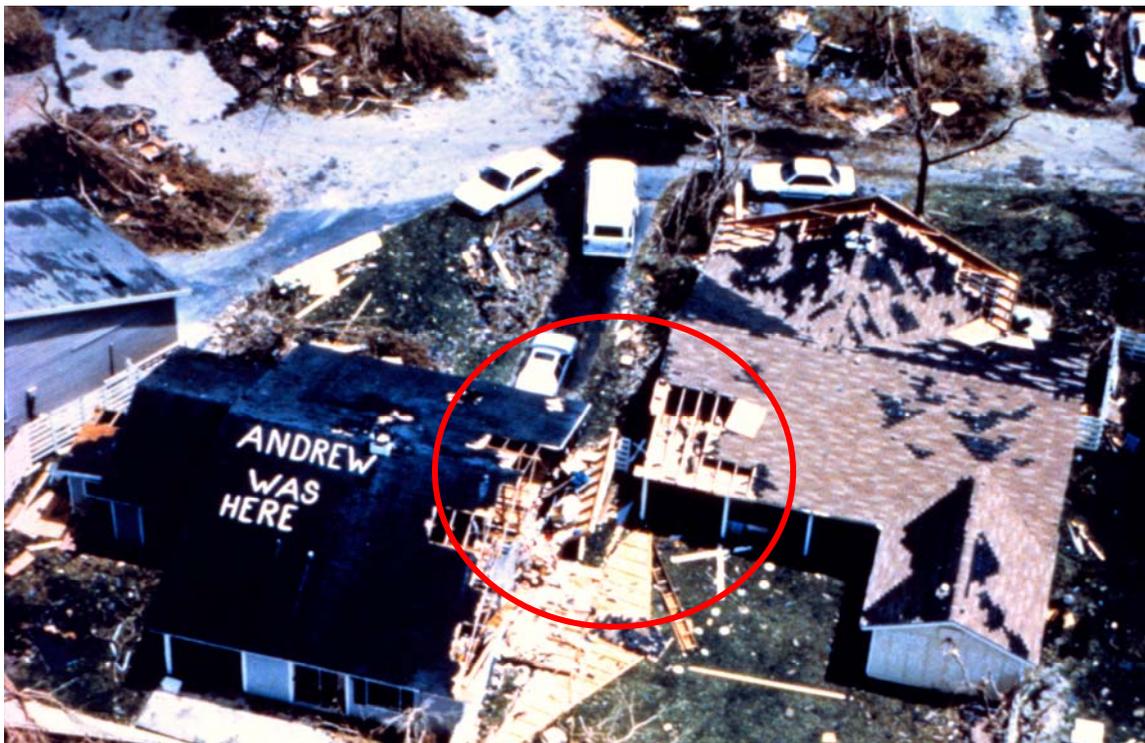
Figure 2: Example of severely damaged shingled roofs.

Figure 2 shows examples of damaged shingle roofs. Both of these houses would be rated “severe” due to the loss of roof deck and collapse of wall shown circled. Houses with either black or white shingles were often graded “Unknown” because of the inability to see details in the photos. In addition bare roof decking also appeared bright white, causing these houses to be graded as “Unknown”. Sometimes roof trusses are left exposed as architectural elements over patios or courtyards. Presence of debris, placement and shape of the openings were used to distinguish these cases from a case of severe roof damage.

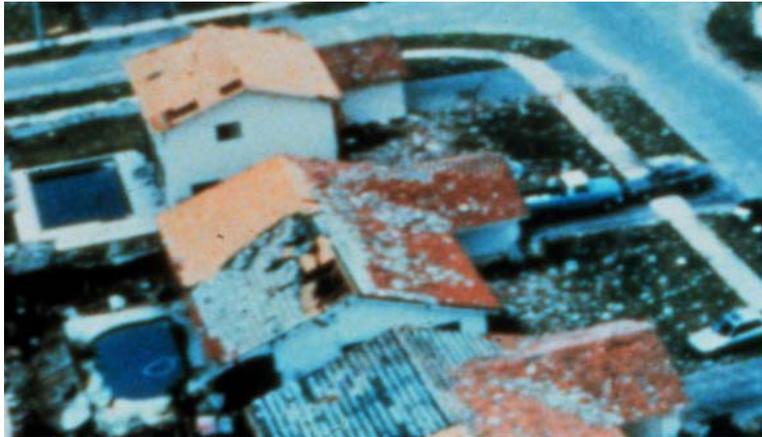
Tile roofs can have flat or barrel tiles. Like the shingles, houses with white tiles were often graded “Unknown”. In some cases, tiles could be seen littering the ground in the downwind direction. Figure 3 shows examples of tile roofs. Notice the tiles scattered on the ground and the built up layers of roofing material on the decking.

Figure 3: Example of damaged tiled roofs with broken tiles scattered on the ground.

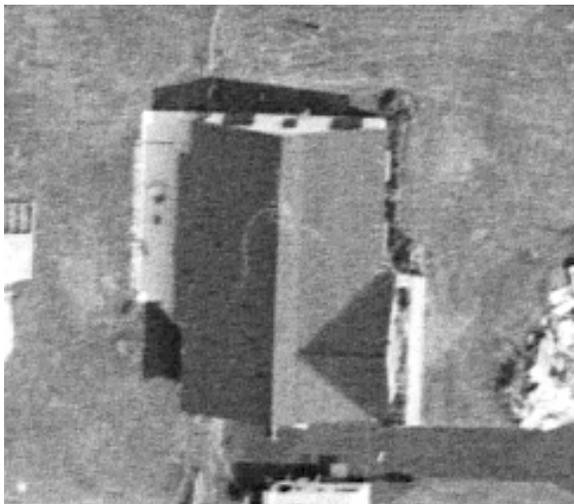
Figure 4: This house is classified as “mild”. There isn’t visible roof damage and the edges of the roof are sharp.

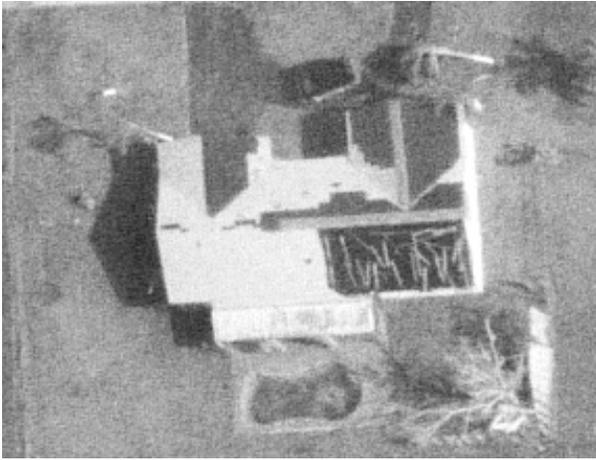
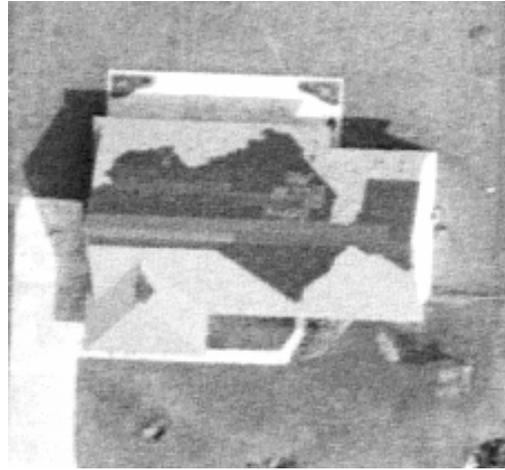
Figure 5: These houses are classified as “moderate”. Both show peeling of the layers of the roof. The owner of the house on the left has nailed strapping to hold down a tarp or tarpaper. The house on the right shows evidence of temporary patching as well.

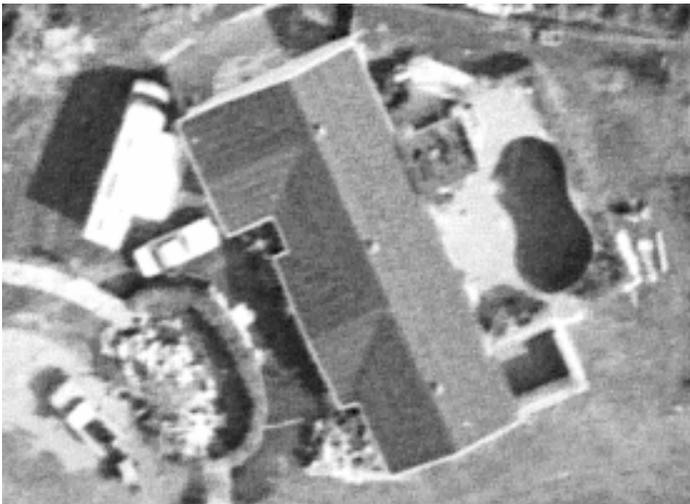
Figure 6: This house is classified as “moderate” as well. The bright edge along with the striping running parallel to the roof ridges suggests that new roofing felt has been applied to the whole roof with metal edge flashing. This level of repair would suggest a “moderate” rating.

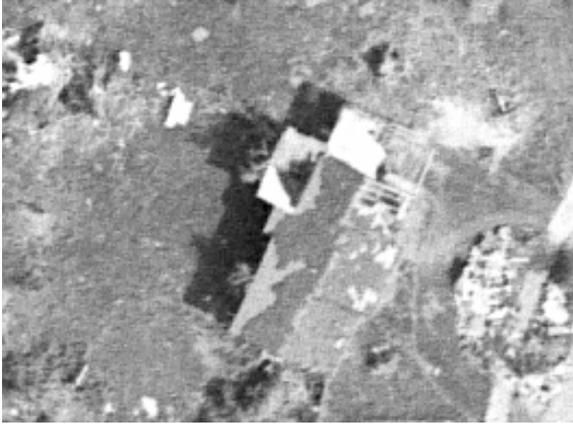
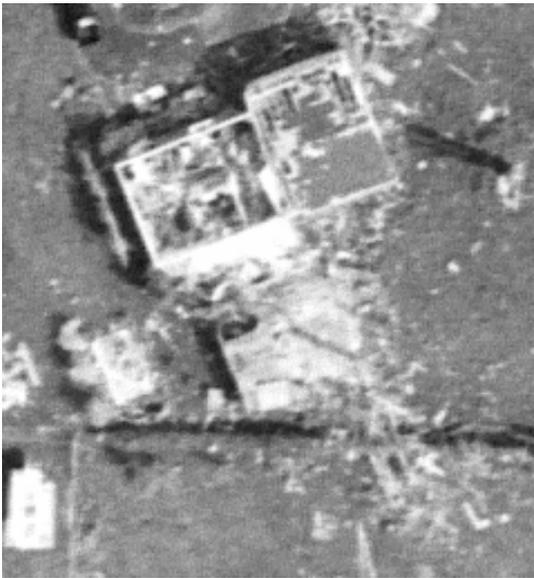
Figure 7: These houses are classified as “severe”. In all cases there is loss of roof decking, and trusses are clearly visible. Debris litters the ground. The house to the left shows a catastrophic loss of the entire roof, which is lying on the ground in front of it.

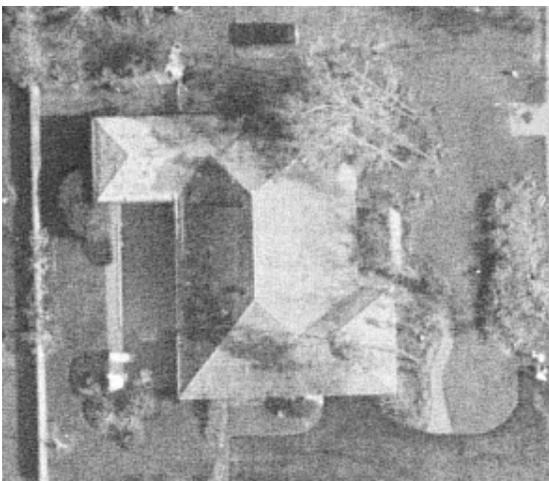
Figure 8: This house is classified as “tree” because a fallen tree is obscuring visibility of the roof.

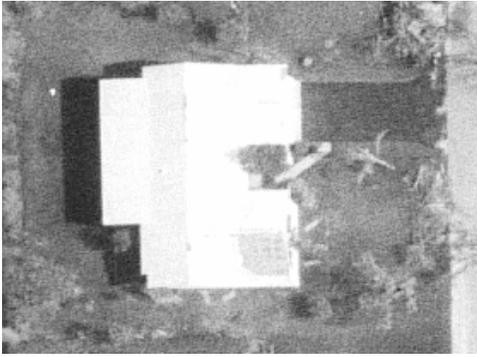
Figure 9: This house is graded as “unknown”. The high reflectance obscures any determination of roof detail.

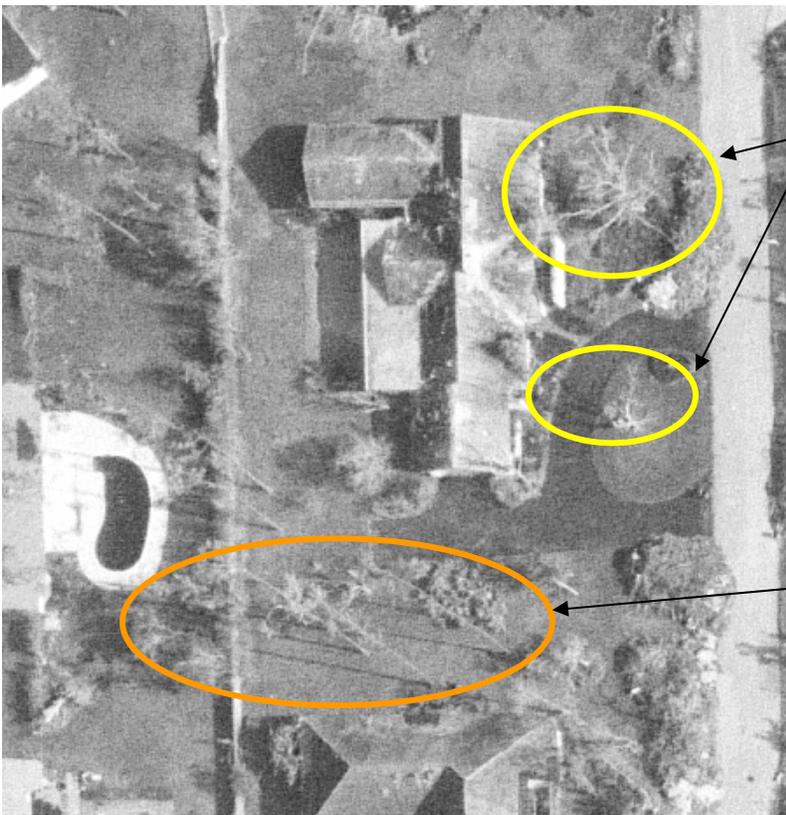
Figure 10:

These broad-leaved trees have remained standing but all the leaves were stripped from the branches. Here the tree can be seen. Sometimes only the shadow reveals the presence of trees. These trees may be been much larger, but the outer canopy branches were all broken.

These long thin single boles belong to trees such as palms or pines. Again the shadows aid in their detection.

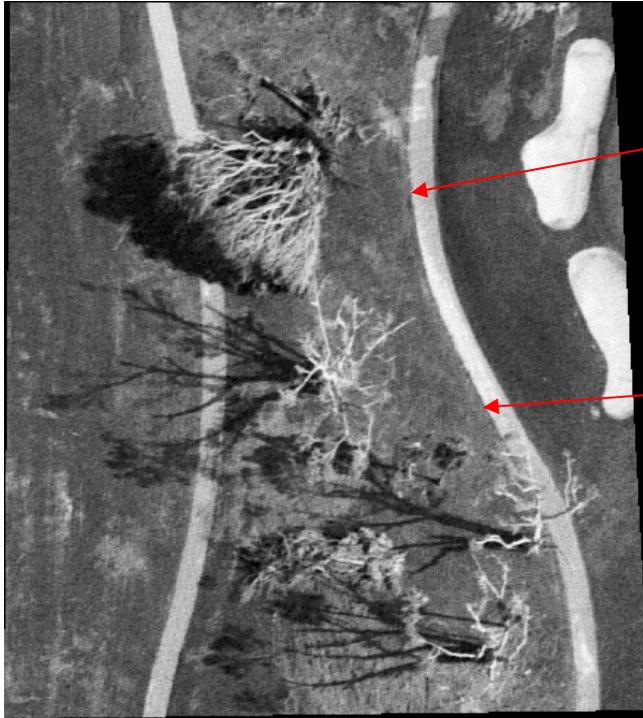
Figure 11:

As shown in Figure 11, some trees can be seen fallen down flat with a tip-up mound containing the root ball. In many cases, homeowners have cleaned up the fallen vegetation and piled it at the curb in front of their homes.

This is an example of a fallen tree with roots exposed.

This tree is still upright but with most of the leaf canopy missing.
