**HURRICANE LOSS REDUCTION  
FOR  
HOUSING IN FLORIDA:**

**PERFORMANCE OF TILE ROOFS  
UNDER HURRICANE IMPACT –  
PHASE 2**

Prepared by:  
Amir Mirmiran, Ton-Lo Wang, Caesar Abishdid,  
Peng Huang, Diego L. Jiménez, and Chadi Younes  
Department of Civil and Environmental Engineering  
Florida International University

August 2007

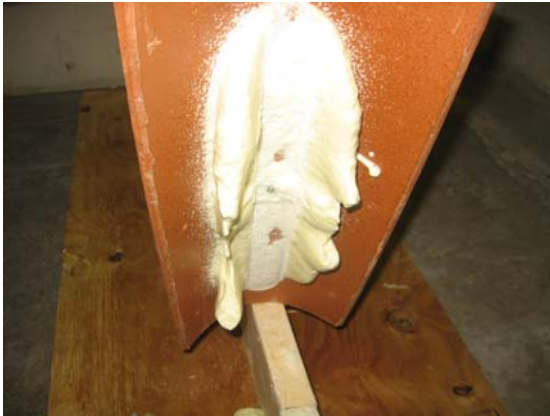
**Figure 3.4: Typical Failure Surface of Adhesive-Set with Clay Tile**

Figures 3.4 and 3.5 show typical failure modes of clay and concrete tiles, respectively. As seen in the figures, little or no foam remained bonded to concrete tiles after failure, while most of the foam remained bonded to clay tiles.

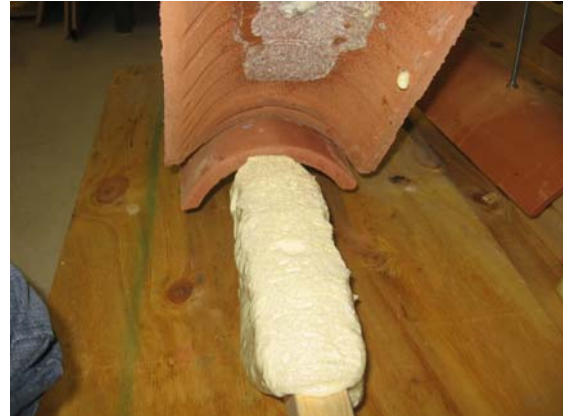
**Figure 3.5: Typical Failure Surface of Adhesive-Set with Concrete Tile**

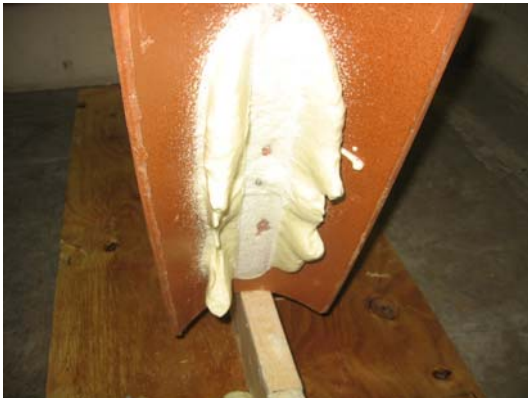
**Figure 3.6: Typical Failure Surface of Adhesive-Set with Clay Tile**

Figures 3.6 and 3.7 show typical failure modes of adhesive-set with clay and concrete tiles, respectively. Concrete tiles exhibited bonding failure at the interface between the tile and the adhesive foam, while clay tiles exhibited bonding failure between the foam and the ridge board. The average uplift resistance for concrete tiles was found to be 283 lbs, while it was 397 lbs for clay tiles. The higher uplift resistance and the exhibited failure mode constitute irrefutable evidence that the foam adheres better to clay tiles than it does to concrete tiles.

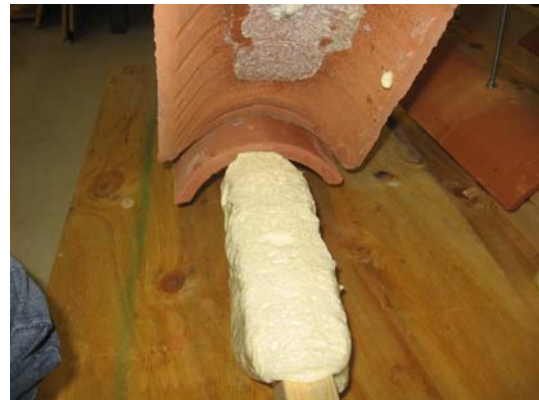
**Figure 3.7: Typical Failure Surface of Adhesive-Set with Concrete Tile**

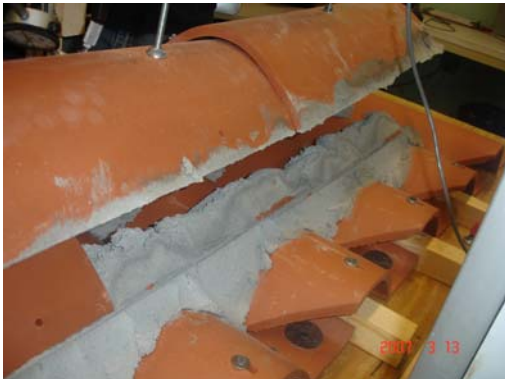
**Figure 3.9: Typical Failure Mode of Clay Tiles with Mortar-Set**

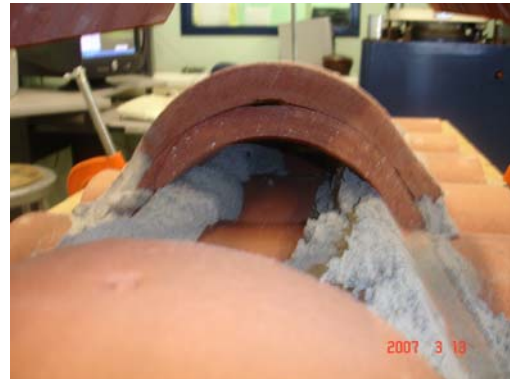
**Figure 3.10: Typical Failure Mode of Concrete Tiles with Mortar-Set**

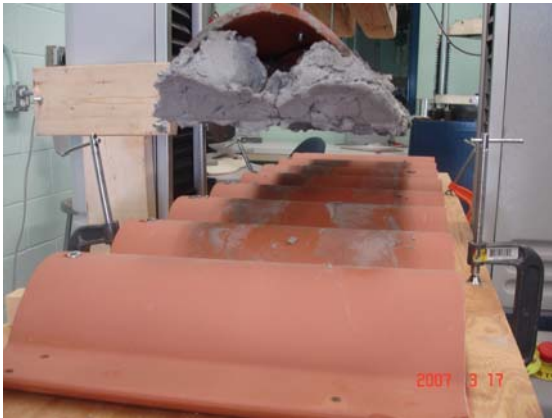
**Figure 3.11: Typical Failure Mode of Clay Tiles with Mortar-Set**

Tables 3.7 and 3.8 list test results for clay and concrete tiles with mortar-set, respectively. Figures 3.11 and 3.12 show typical failure modes for clay and concrete tiles, respectively. The failure load was taken to be the load required to cause additional deflection without any further resistance. The average uplift resistance for concrete tiles was found to be 565 lbs. Clay tiles, on the other hand, exhibited bonding failure at the interface between the field tiles and the mortar. The average uplift resistance was only 60 lbs, or 11% of that of concrete tiles.

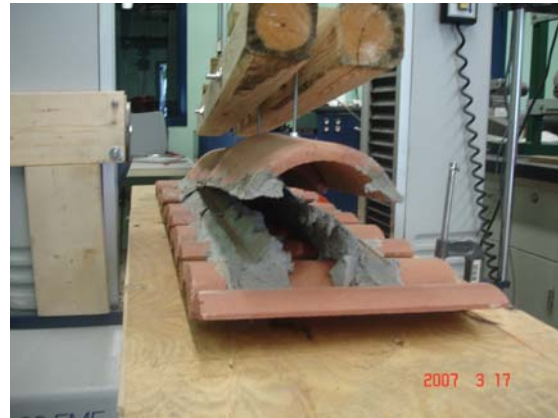
**Figure 3.12: Typical Failure Mode of Concrete Tiles with Mortar-Set**

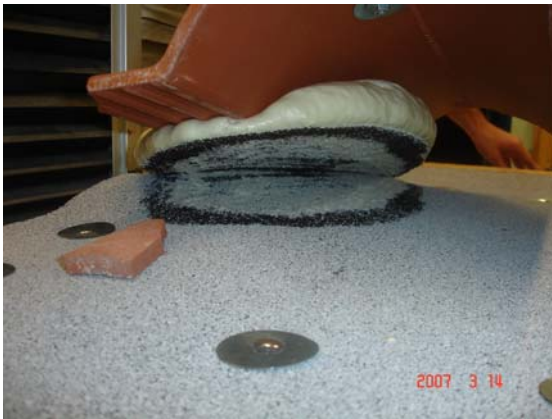
**Figure 3.16: Typical Failure Surface of Clay Tiles with Adhesive-Set**

Figures 3.16 and 3.17 show typical failure surfaces of clay and concrete tiles with adhesive-set, respectively. Concrete tiles showed bonding failure at the interface between the tile and the adhesive foam. Little or no foam remained bonded to concrete tiles after failure, as shown in Figure 3.17. The average uplift resistance for concrete tiles was 121 lbs. Clay tiles, on the other hand, failed at the interface of the foam and the underlayment. The average uplift resistance for the clay tiles was 128 lbs.

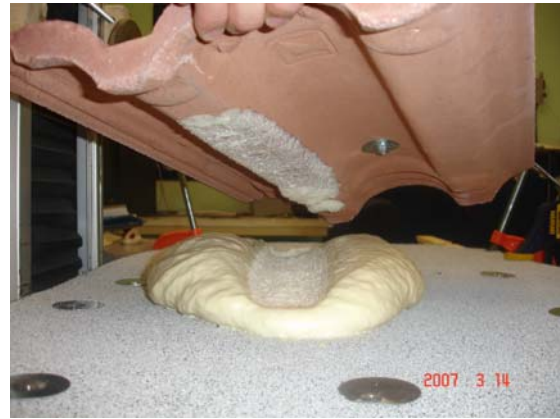
**Figure 3.17: Typical Failure Surface of Concrete Tiles with Adhesive-Set**

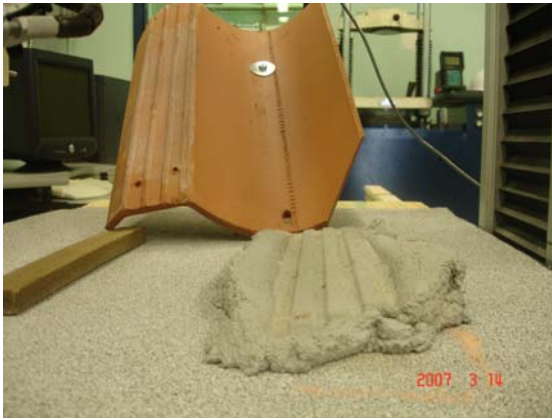
**Figure 3.18: Typical Failure Surface of Clay Tile with Mortar-Set**

Figures 3.18 and 3.19 show the typical failure surfaces of clay and concrete tiles with mortar-set, respectively. Concrete tiles exhibited bonding failure at the interface between the mortar and the underlayment. The average uplift resistance for concrete tiles was found to be 108 lbs. Clay tiles, on the other hand, exhibited failure at the interface between the tile and the mortar. The average uplift resistance for clay tiles was only 58 lbs, or 54% of that of concrete tiles.

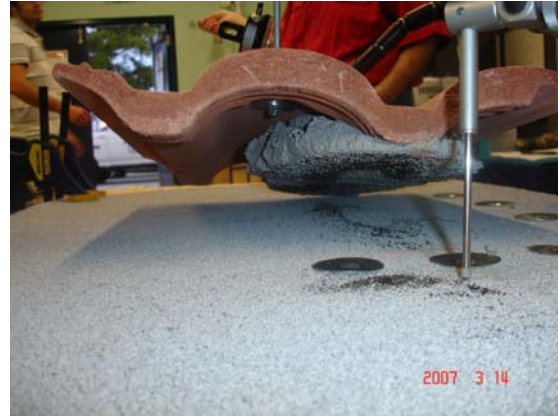
**Figure 3.19: Typical Failure Surface of Concrete Tile with Mortar-Set**

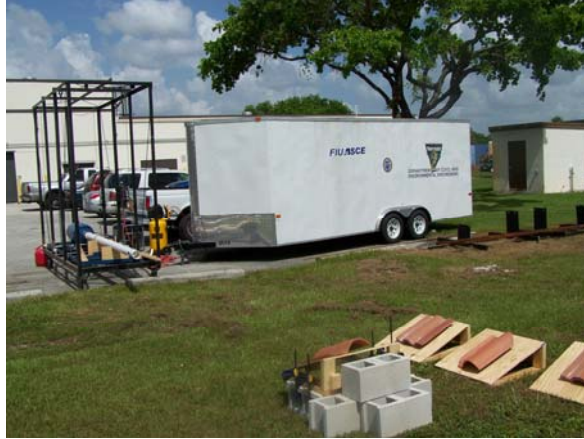
**Figure 4.2: Air Cannon Impact Test for Single Field Tiles**

In the first experiment, three individual samples of clay and concrete field tiles were attached to a ½ piece of plywood deck using the same mechanical attachment system, as described in the Section 3. The plywood deck was in-turn mounted on 2"x 4" rafters spaced at 24" on center. The specimens were placed on a wooden frame with a 4:12 slope (typical of residential roofs) placed at 32 ft away from the air cannon, as shown in Figure 4.2. A 3 ft piece of 2"x 4" Southern Pine lumber was used as the projectile in these experiments.

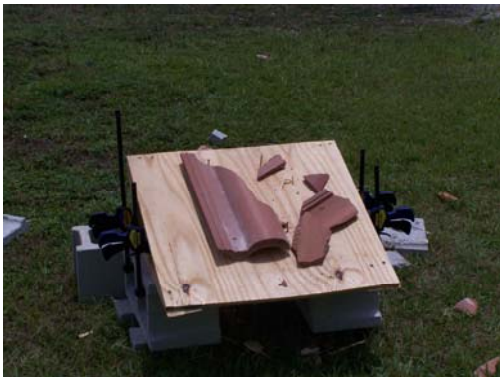
**Figure 4.3: Single Concrete Field Tile After Projectile Impact**

The experiments showed that both concrete and clay field tiles would fail under the impact of the 2"x 4" lumber at 5 psi cannon air pressure – the lowest readable pressure on the gage. What was interesting in the results of this test is the mode of failure for each type of tile. While concrete tiles only broke in half (Figure 4.3), clay tiles were totally shattered by the impact with very little remaining on the plywood deck (Figure 4.4).

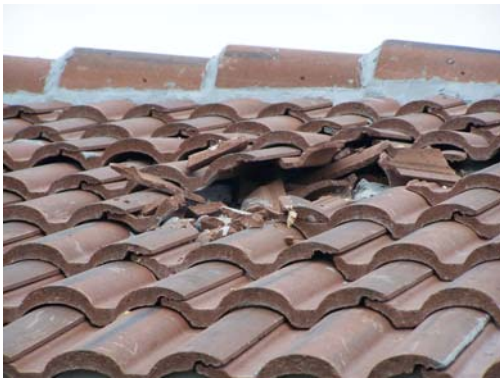
**Figure 4.5: Impact Test on Concrete with Mortar Tile Roof System**

Figure 4.5 shows the concrete tiles with mortar absorbed the impact of the projectile to a large extent while sustaining minimal damage. The roof tiles in the impact area were damaged, but no tiles flew off of the roof. Figure 4.6 shows the clay tiles with foam sustained extensive damage in and around the impact area. Many of the clay tiles were launched into the air as projectiles upon impact. The damage shown in Figure 4.5 however, is not entirely the result of the projectile impact. Initial damage amounting to about 13 tiles was caused by the WoW test. Figure 4.7 shows several photographic frames for air cannon impact tests of concrete tiles.

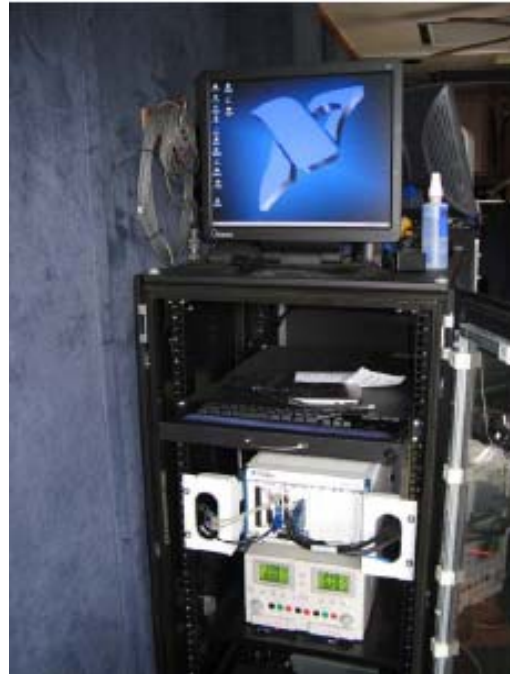
Figure 5.3: DAQ System for WoW Testing

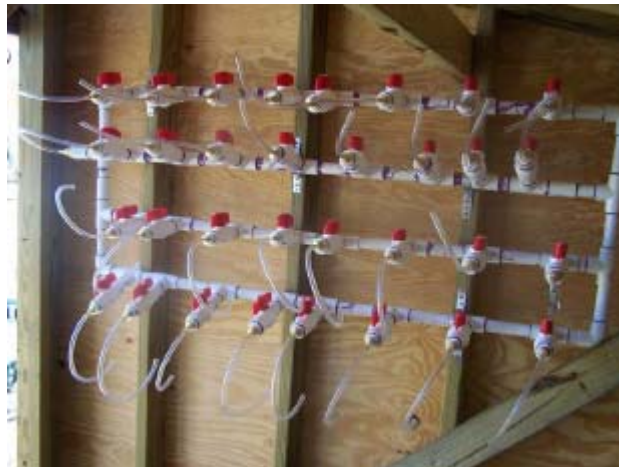
**Figure 5.6: PVC Reference Pressure Manifold**

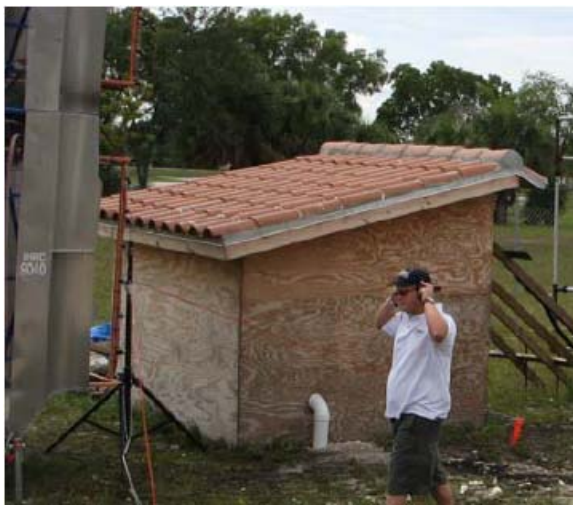
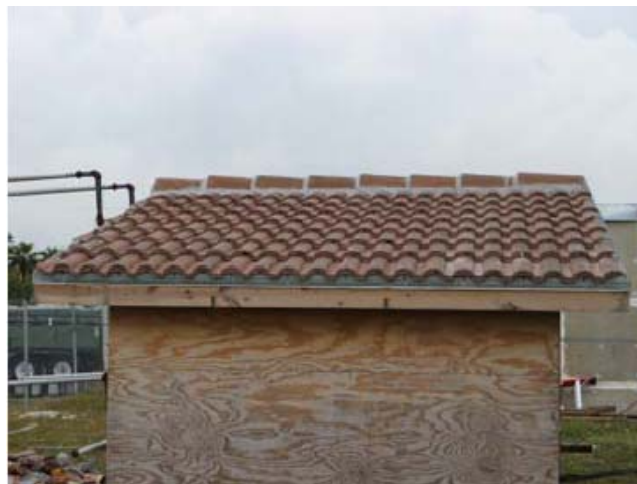
(c) Model 2: Clay Roof Tiles with Mortar

(e) Model 4: Concrete Roof Tiles with Mortar

**Figure 5.10: Tile Roof Test Models**

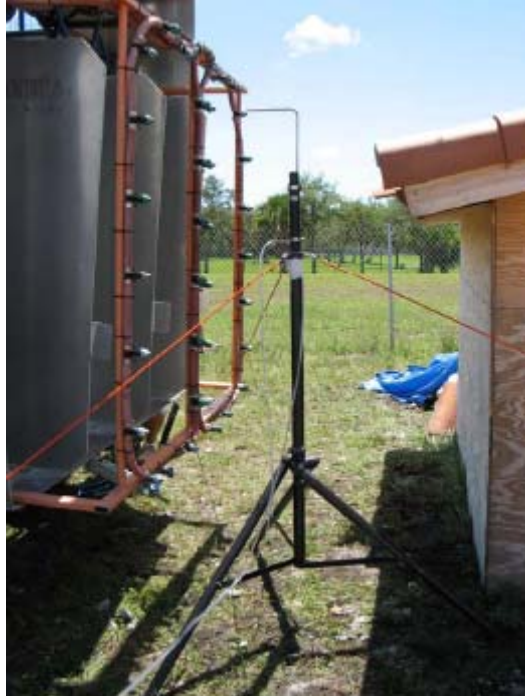
**Figure 5.12: Pitot Wind Tube for Measuring Wind Speed**

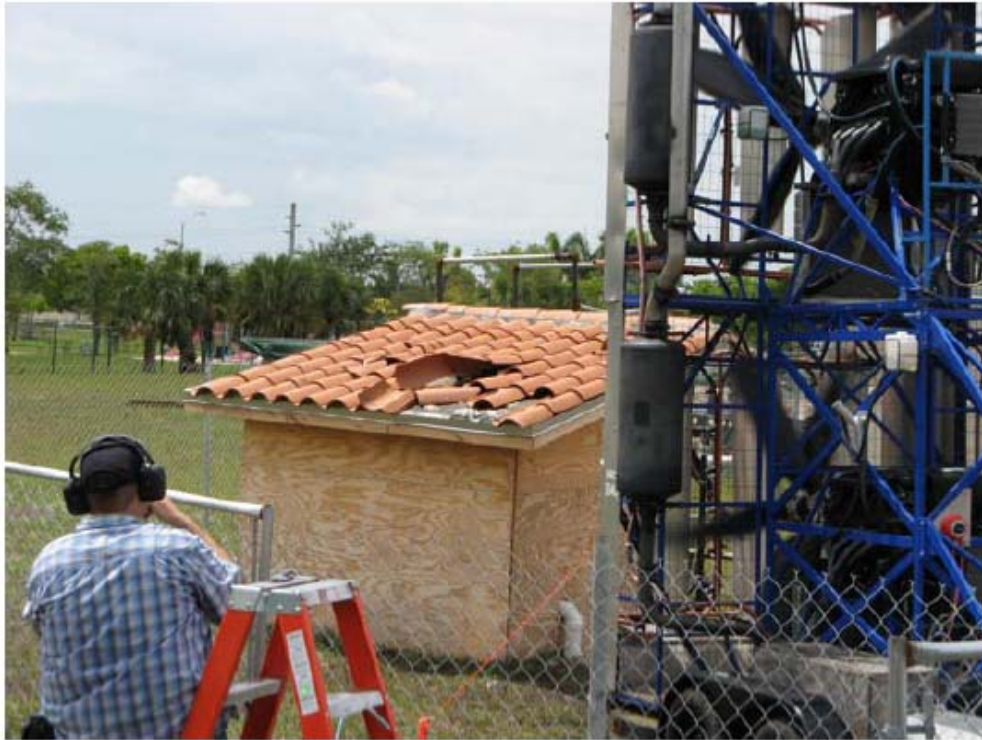
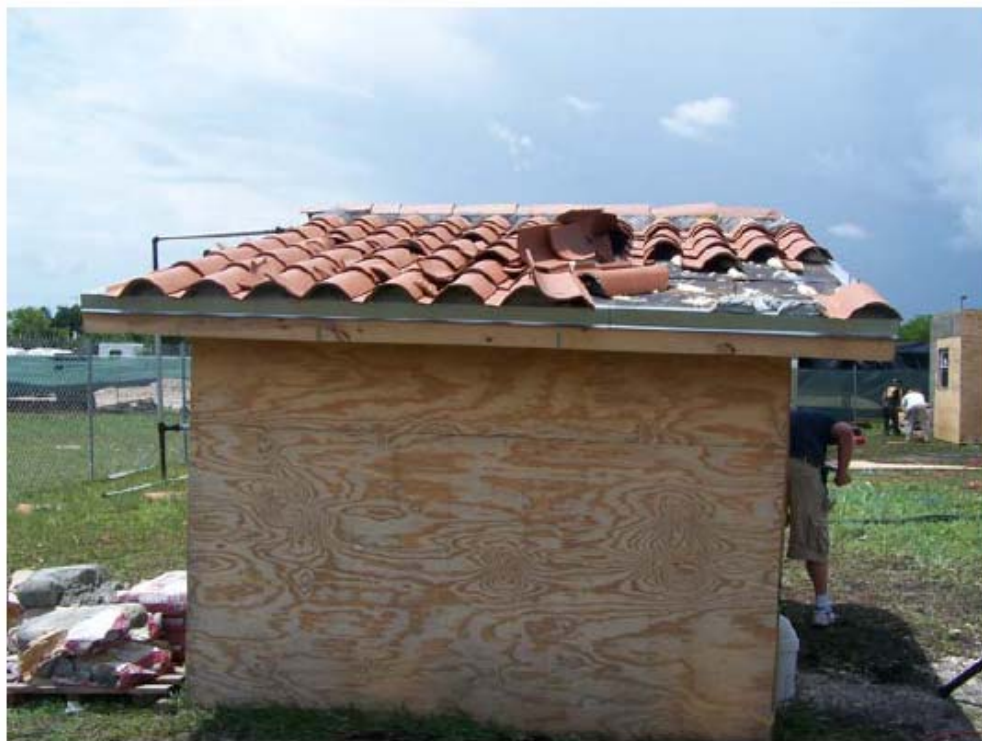
(a) Roof Condition Subjected to 120 mph Wind Speed at 0° Direction

(b) Roof Condition Subjected to 120 mph Wind Speed at 50° Direction

**Figure 5.15: Failure of Clay-with-Foam Tile Roof System**

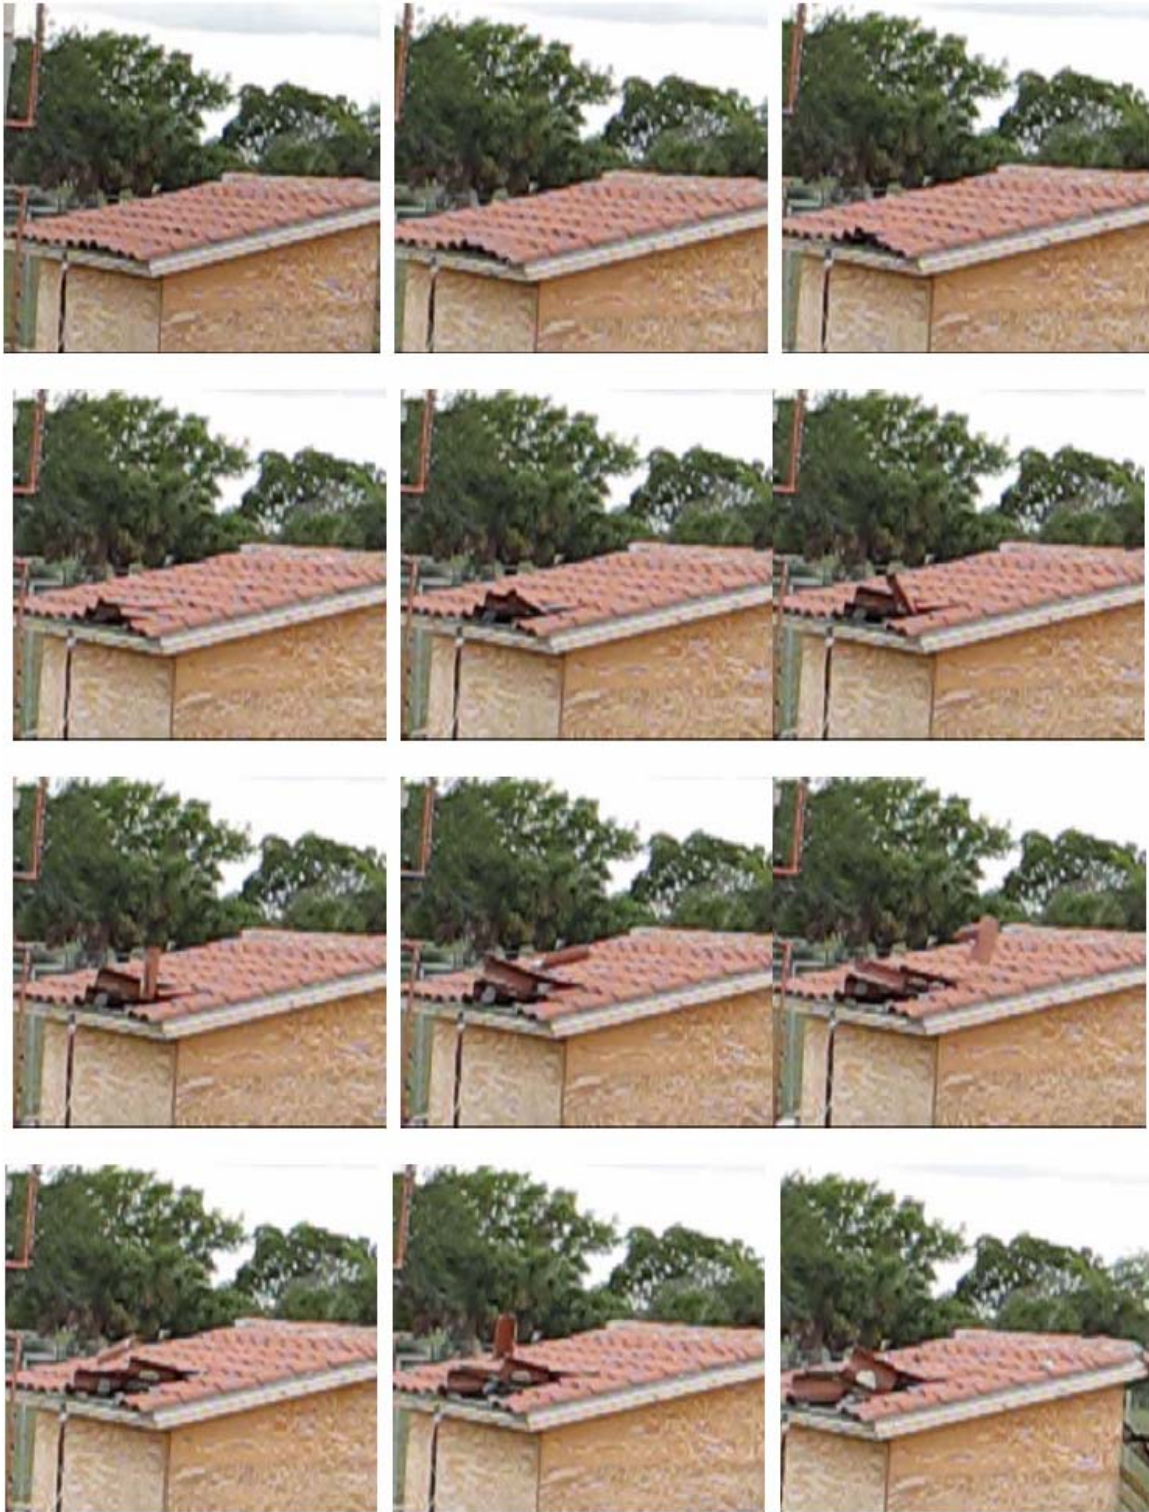
**Figure 5.16: Failure Progress of Clay-with-Foam Tile Roof System  
(120 mph Wind Speed at 0° Direction)**

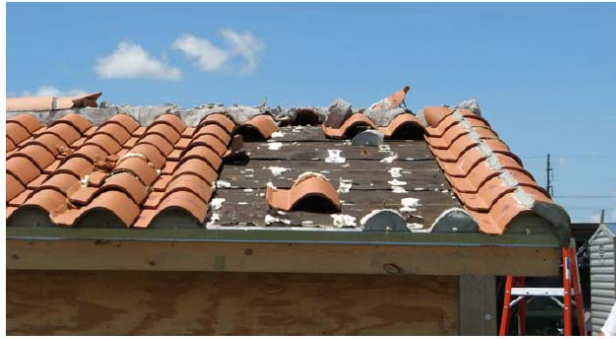
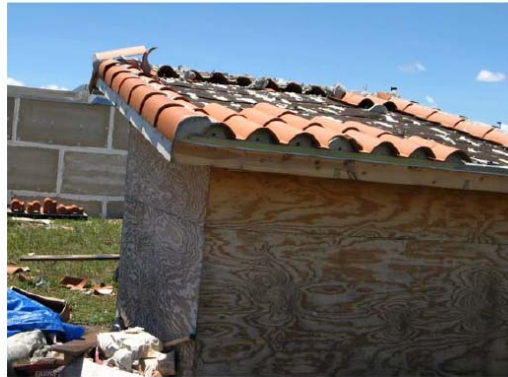
(a) Roof Conditions Subjected to 120 mph Wind Speed at 0° Direction

(b) Roof Conditions Subjected to 120 mph Wind Speed at 50° Direction

**Figure 5.18: Failure of Clay-with-Foam Tile Roof System with Extra Ridge Tiles on the Side**

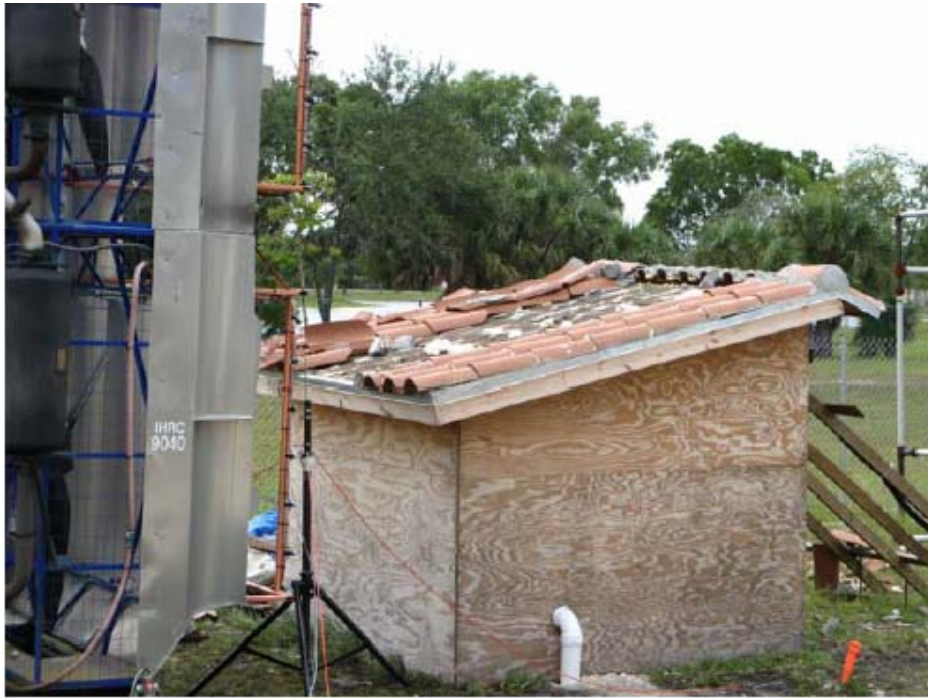
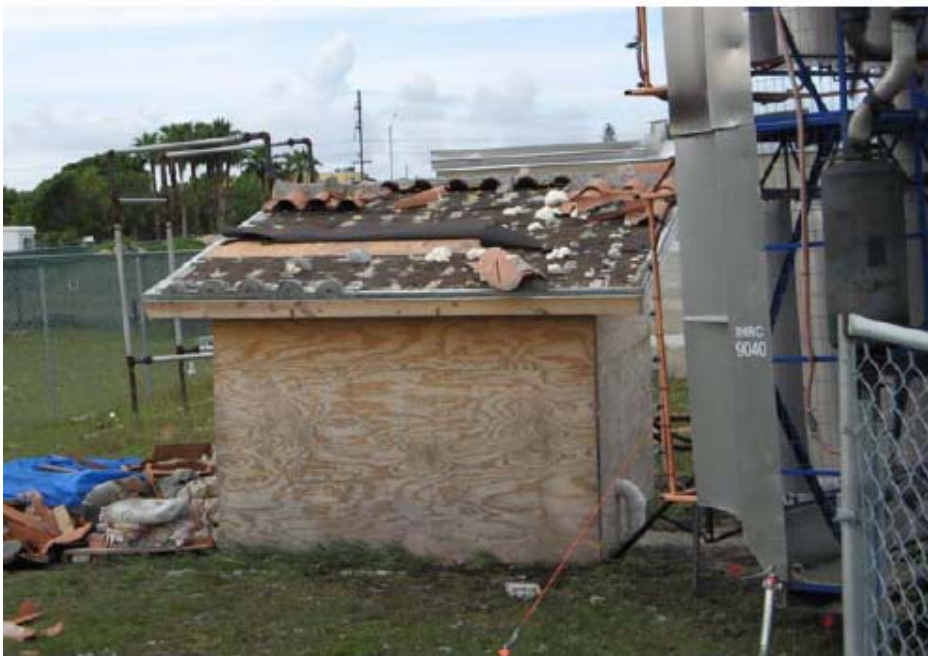
(a) Roof Conditions Subjected to 120 mph Wind Speed at  $0^{\circ}$  Direction

(b) Roof Conditions Subjected to 120 mph Wind Speed at  $50^{\circ}$  Direction

**Figure 5.22: Failure of Clay-with-Mortar Tile Roof System**

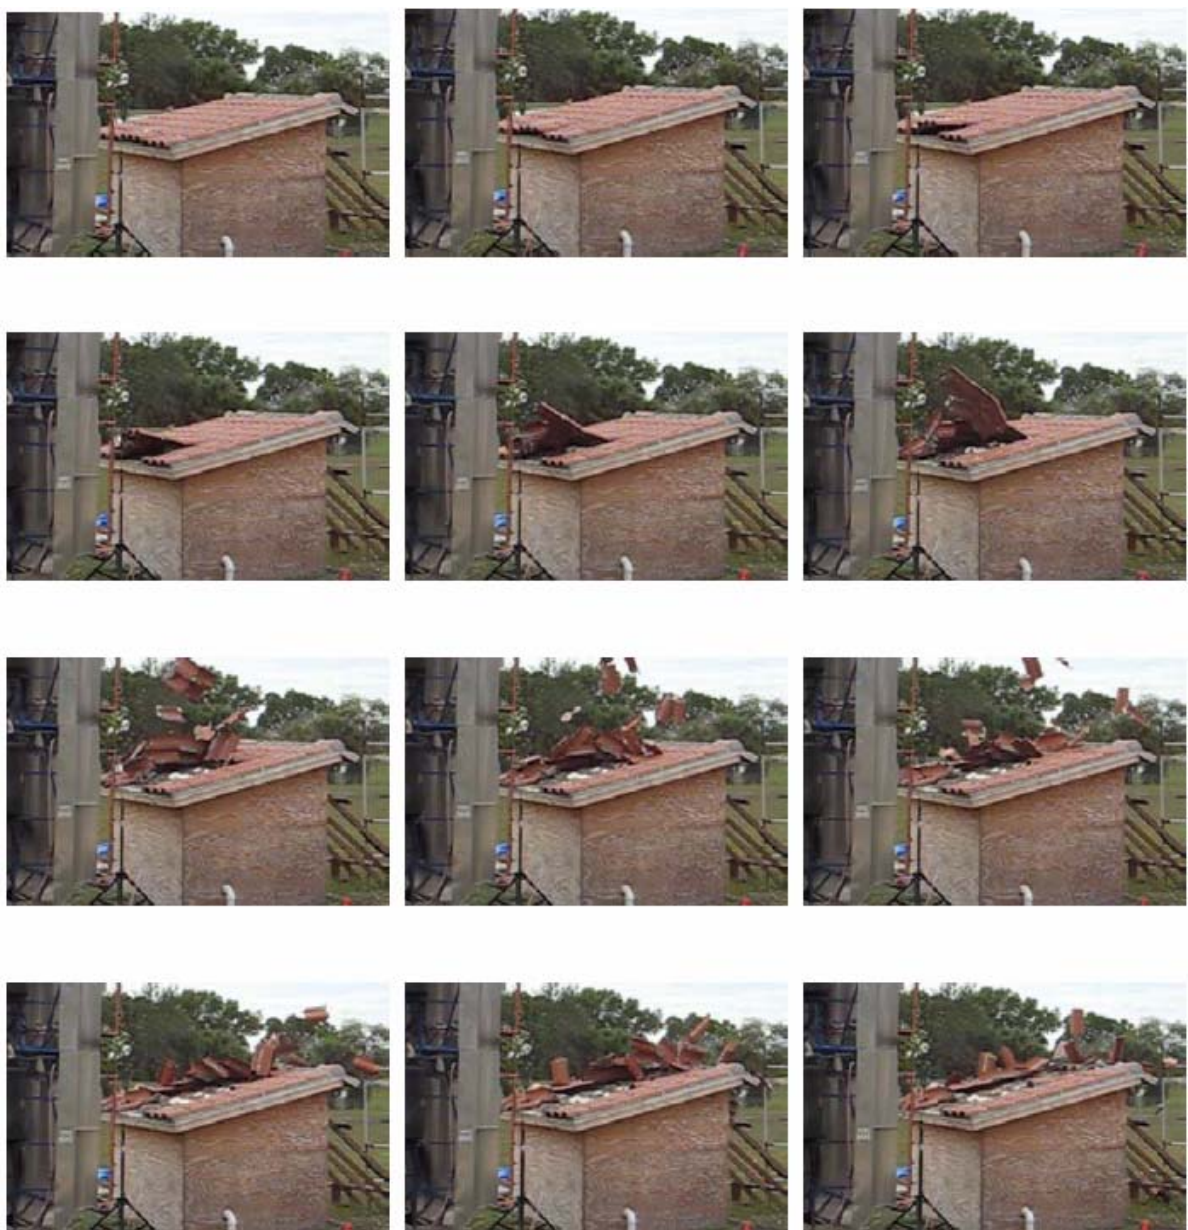
**Figure 5.23: Failure Progress of Clay-with-Mortar Tile Roof System (120 mph Wind Speed at 0° Direction)**

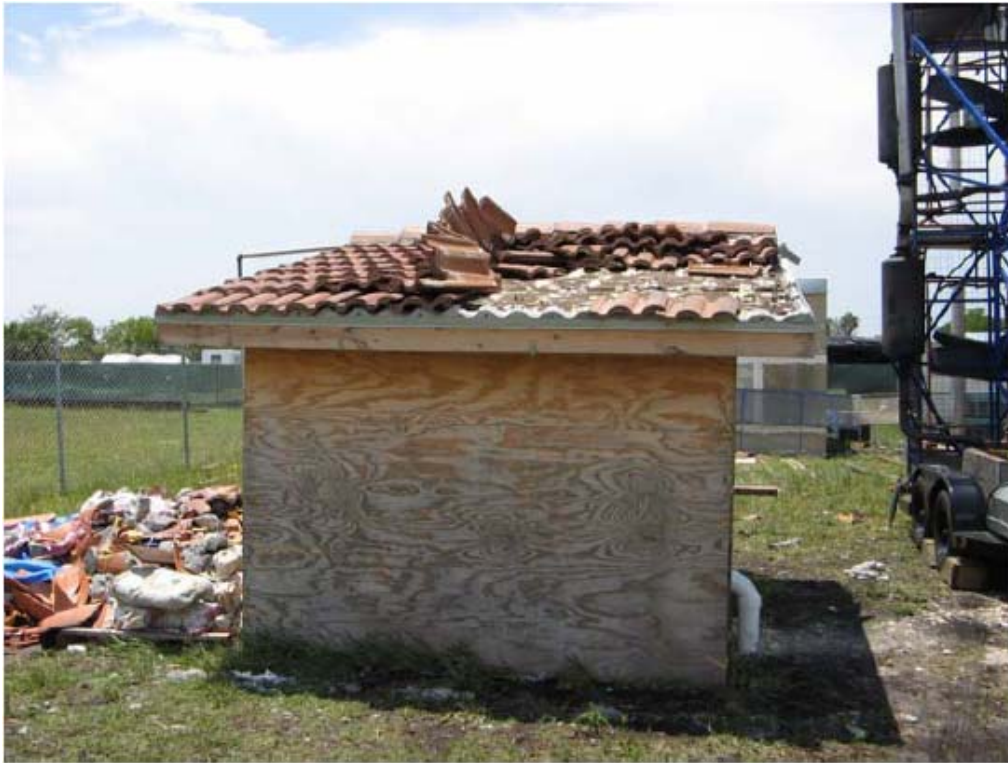
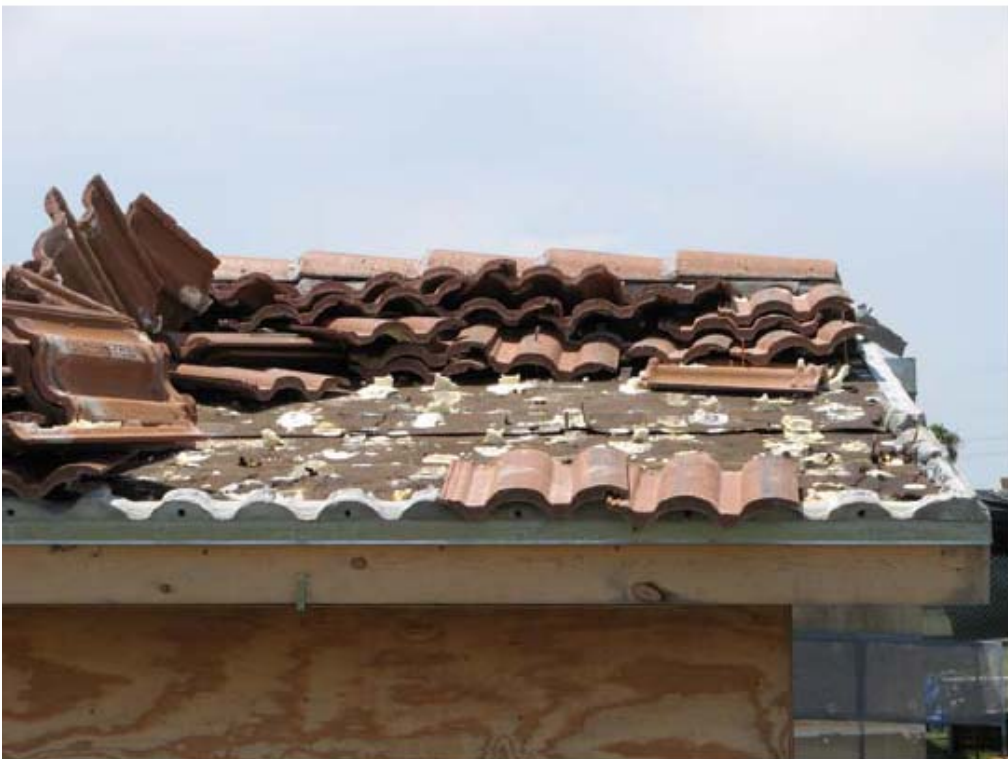
(a) Roof Conditions Subjected to 120 mph Wind Speed at  $50^{\circ}$  Direction

(b) Roof Conditions Subjected to 120 mph Wind Speed at  $50^{\circ}$  Direction

**Figure 5.26: Failure of Concrete-with-Foam Tile Roof System**

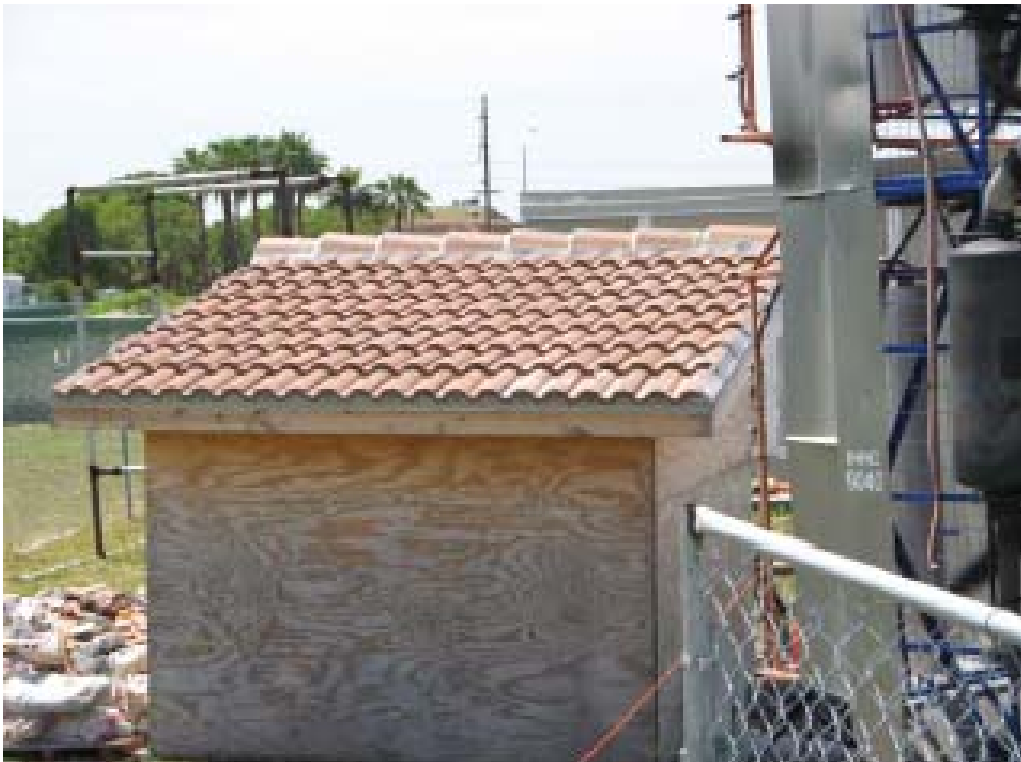
**Figure 5.29: Concrete-with-Mortar Tile Roof System after Wind Testing**

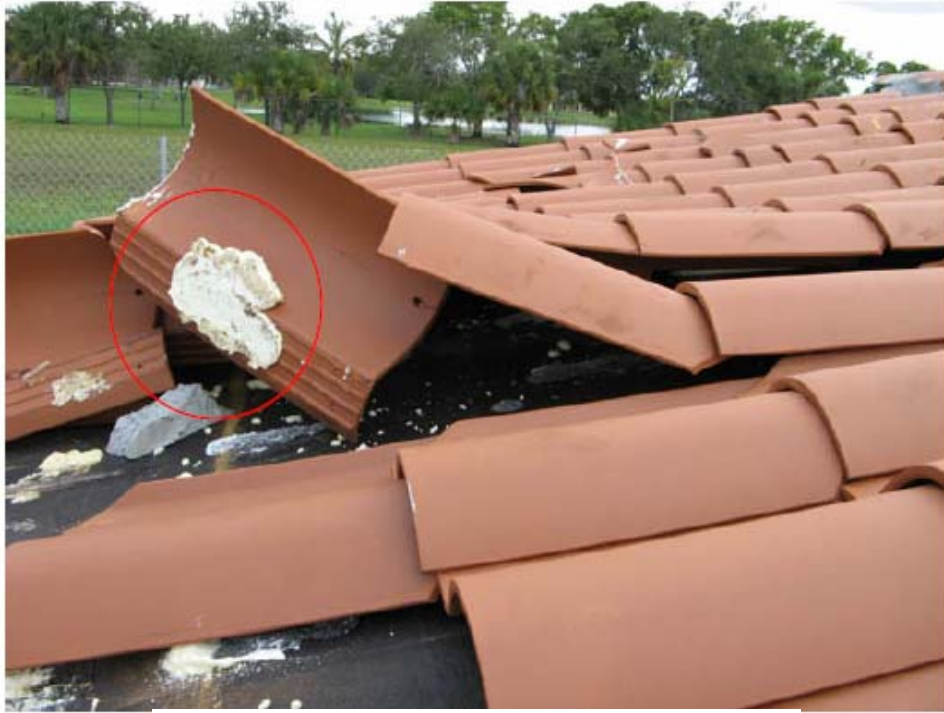
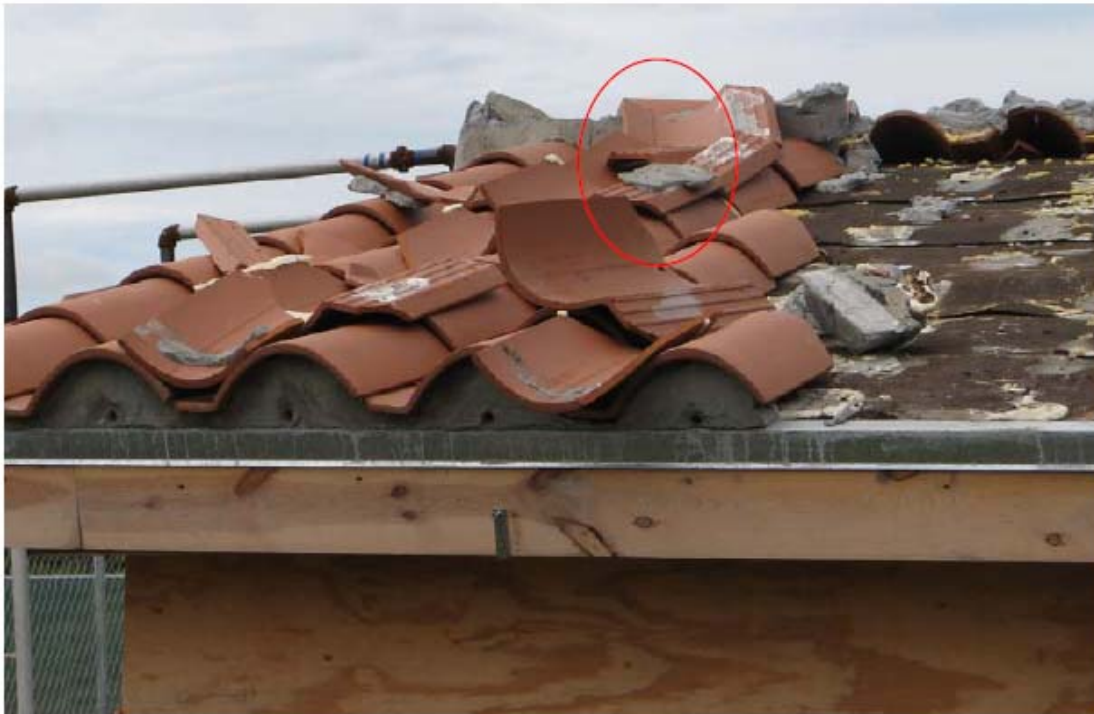
(a) Clay Tile Roof with Foam in Model 1a

(b) Clay Tile Roof with Mortar in Model 2
