HURRICANE LOSS REDUCTION

HOUSING IN FLORIDA:

Performance of Gable End Wall Bracing Retrofit for Hurricane Protection

PHASE II

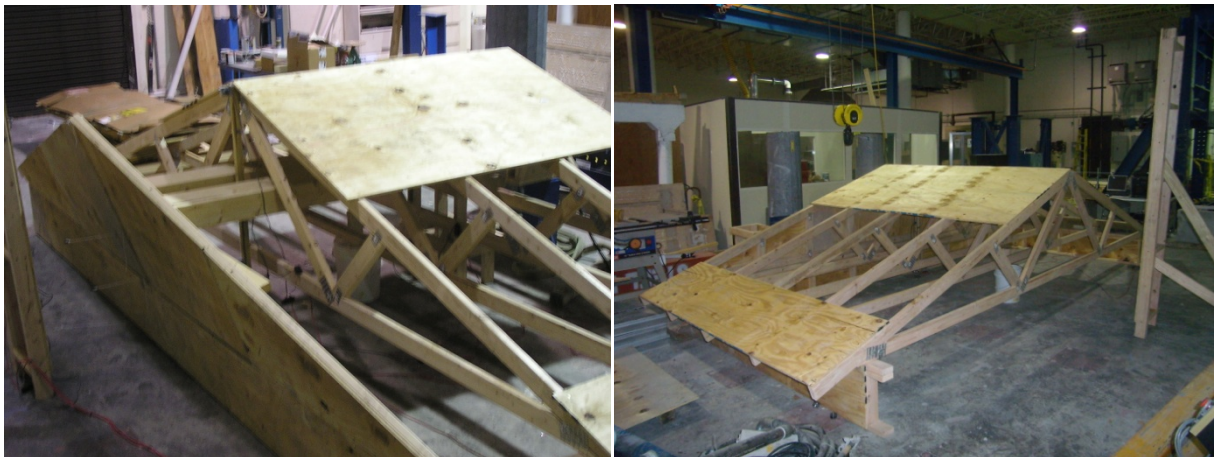
Figure 4. Test Setup with Semi-Covered and Fully-Covered Sheathing.

drawn from Phase 1 that suggested that “the sheathing can play a major role in preventing the collapsing of the gable-end if they remain intact during a hurricane”, another test setup with sheathing material covering the gable-end wall and the first truss was also studied. Figure 4 illustrates the semi-covered structure and fully-covered structure used in this study.
