**HURRICANE LOSS REDUCTION
FOR
HOUSING IN FLORIDA:**

ROOF SHEATHING FASTENER STUDY

PREPARED BY
THE INTERNATIONAL HURRICANE RESEARCH CENTER
FLORIDA INTERNATIONAL UNIVERSITY

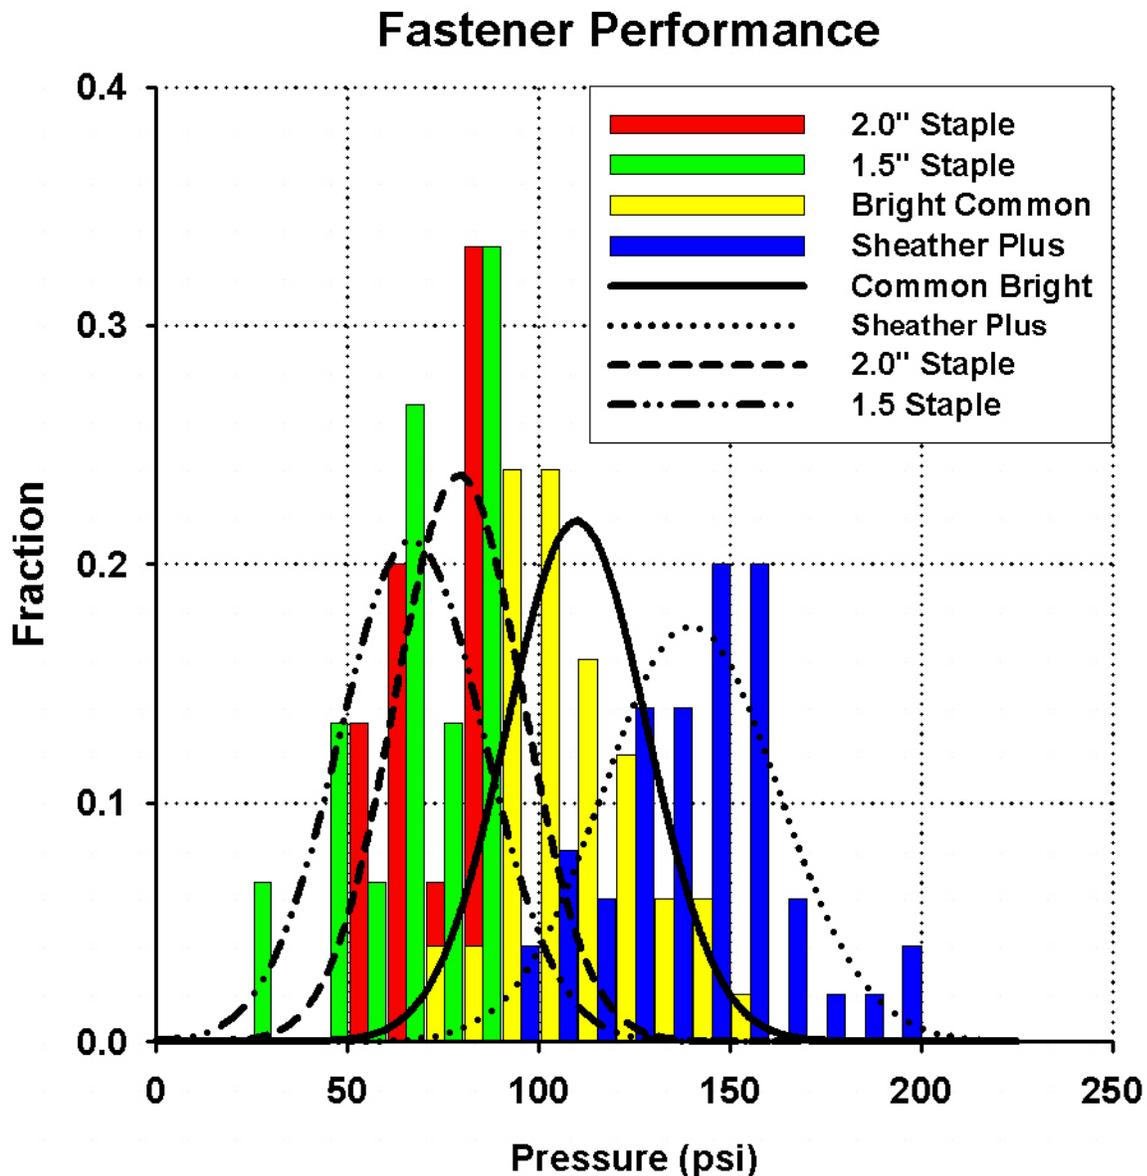
After testing was completed, statistical analysis was performed using the results to determine relationships between pullout pressures and fastener types. Histograms and PDF fits are shown in Figure 1. Both staple types had only about half of the pullout capacity of the Sheather Plus nail. The 1.5” staple leg staple had a mean pullout capacity of 67 psi while the 2” staple leg staple performed slightly better with a mean pullout capacity of 79 psi. The Sheather Plus nail performed exceptionally well with a mean pullout capacity of 140 psi, as compared to 106 psi measured with common bright 8d nails.
